# Great Harmeston Solar Farm

## Construction Traffic

## Management Plan

**Great Harmeston Solar Farm, Pembrokeshire.**

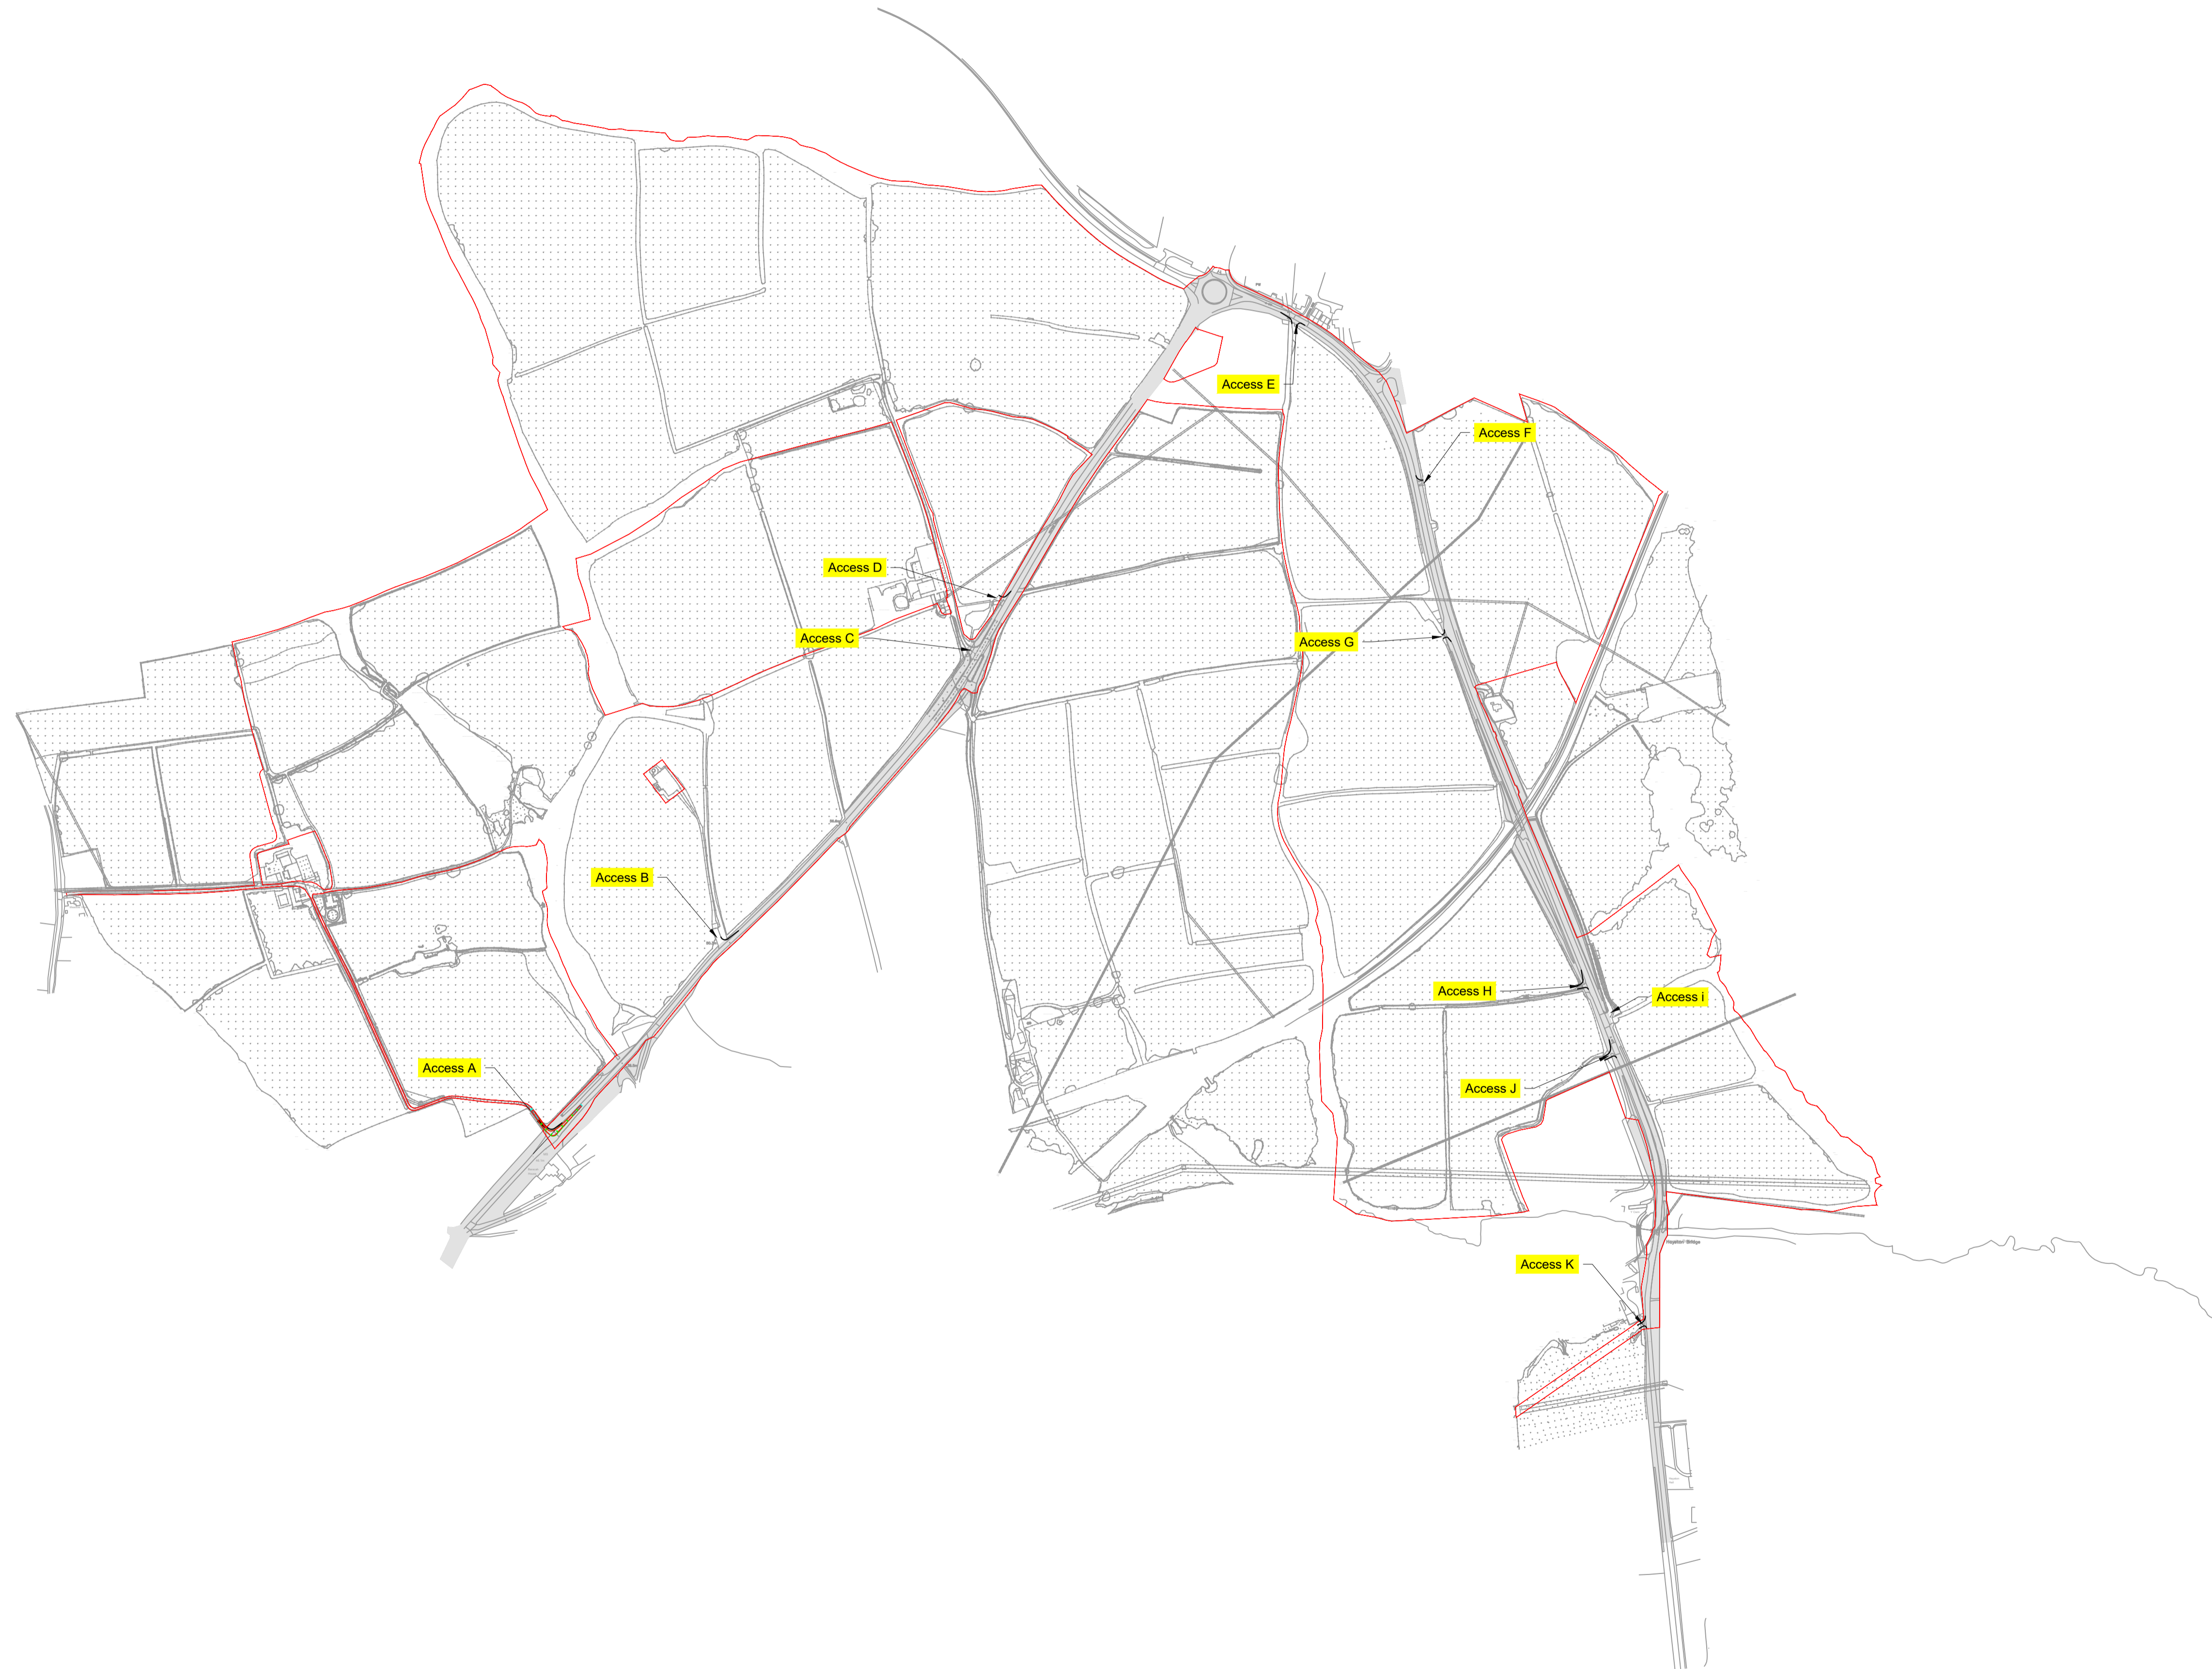
**PROPOSED ACCESS ARRANGEMENTS -  
ACCESS LOCATIONS**

- Key:
- Approximate Red Line Boundary
  - Visibility Splay
  - Approximate Extent of Adopted Highway

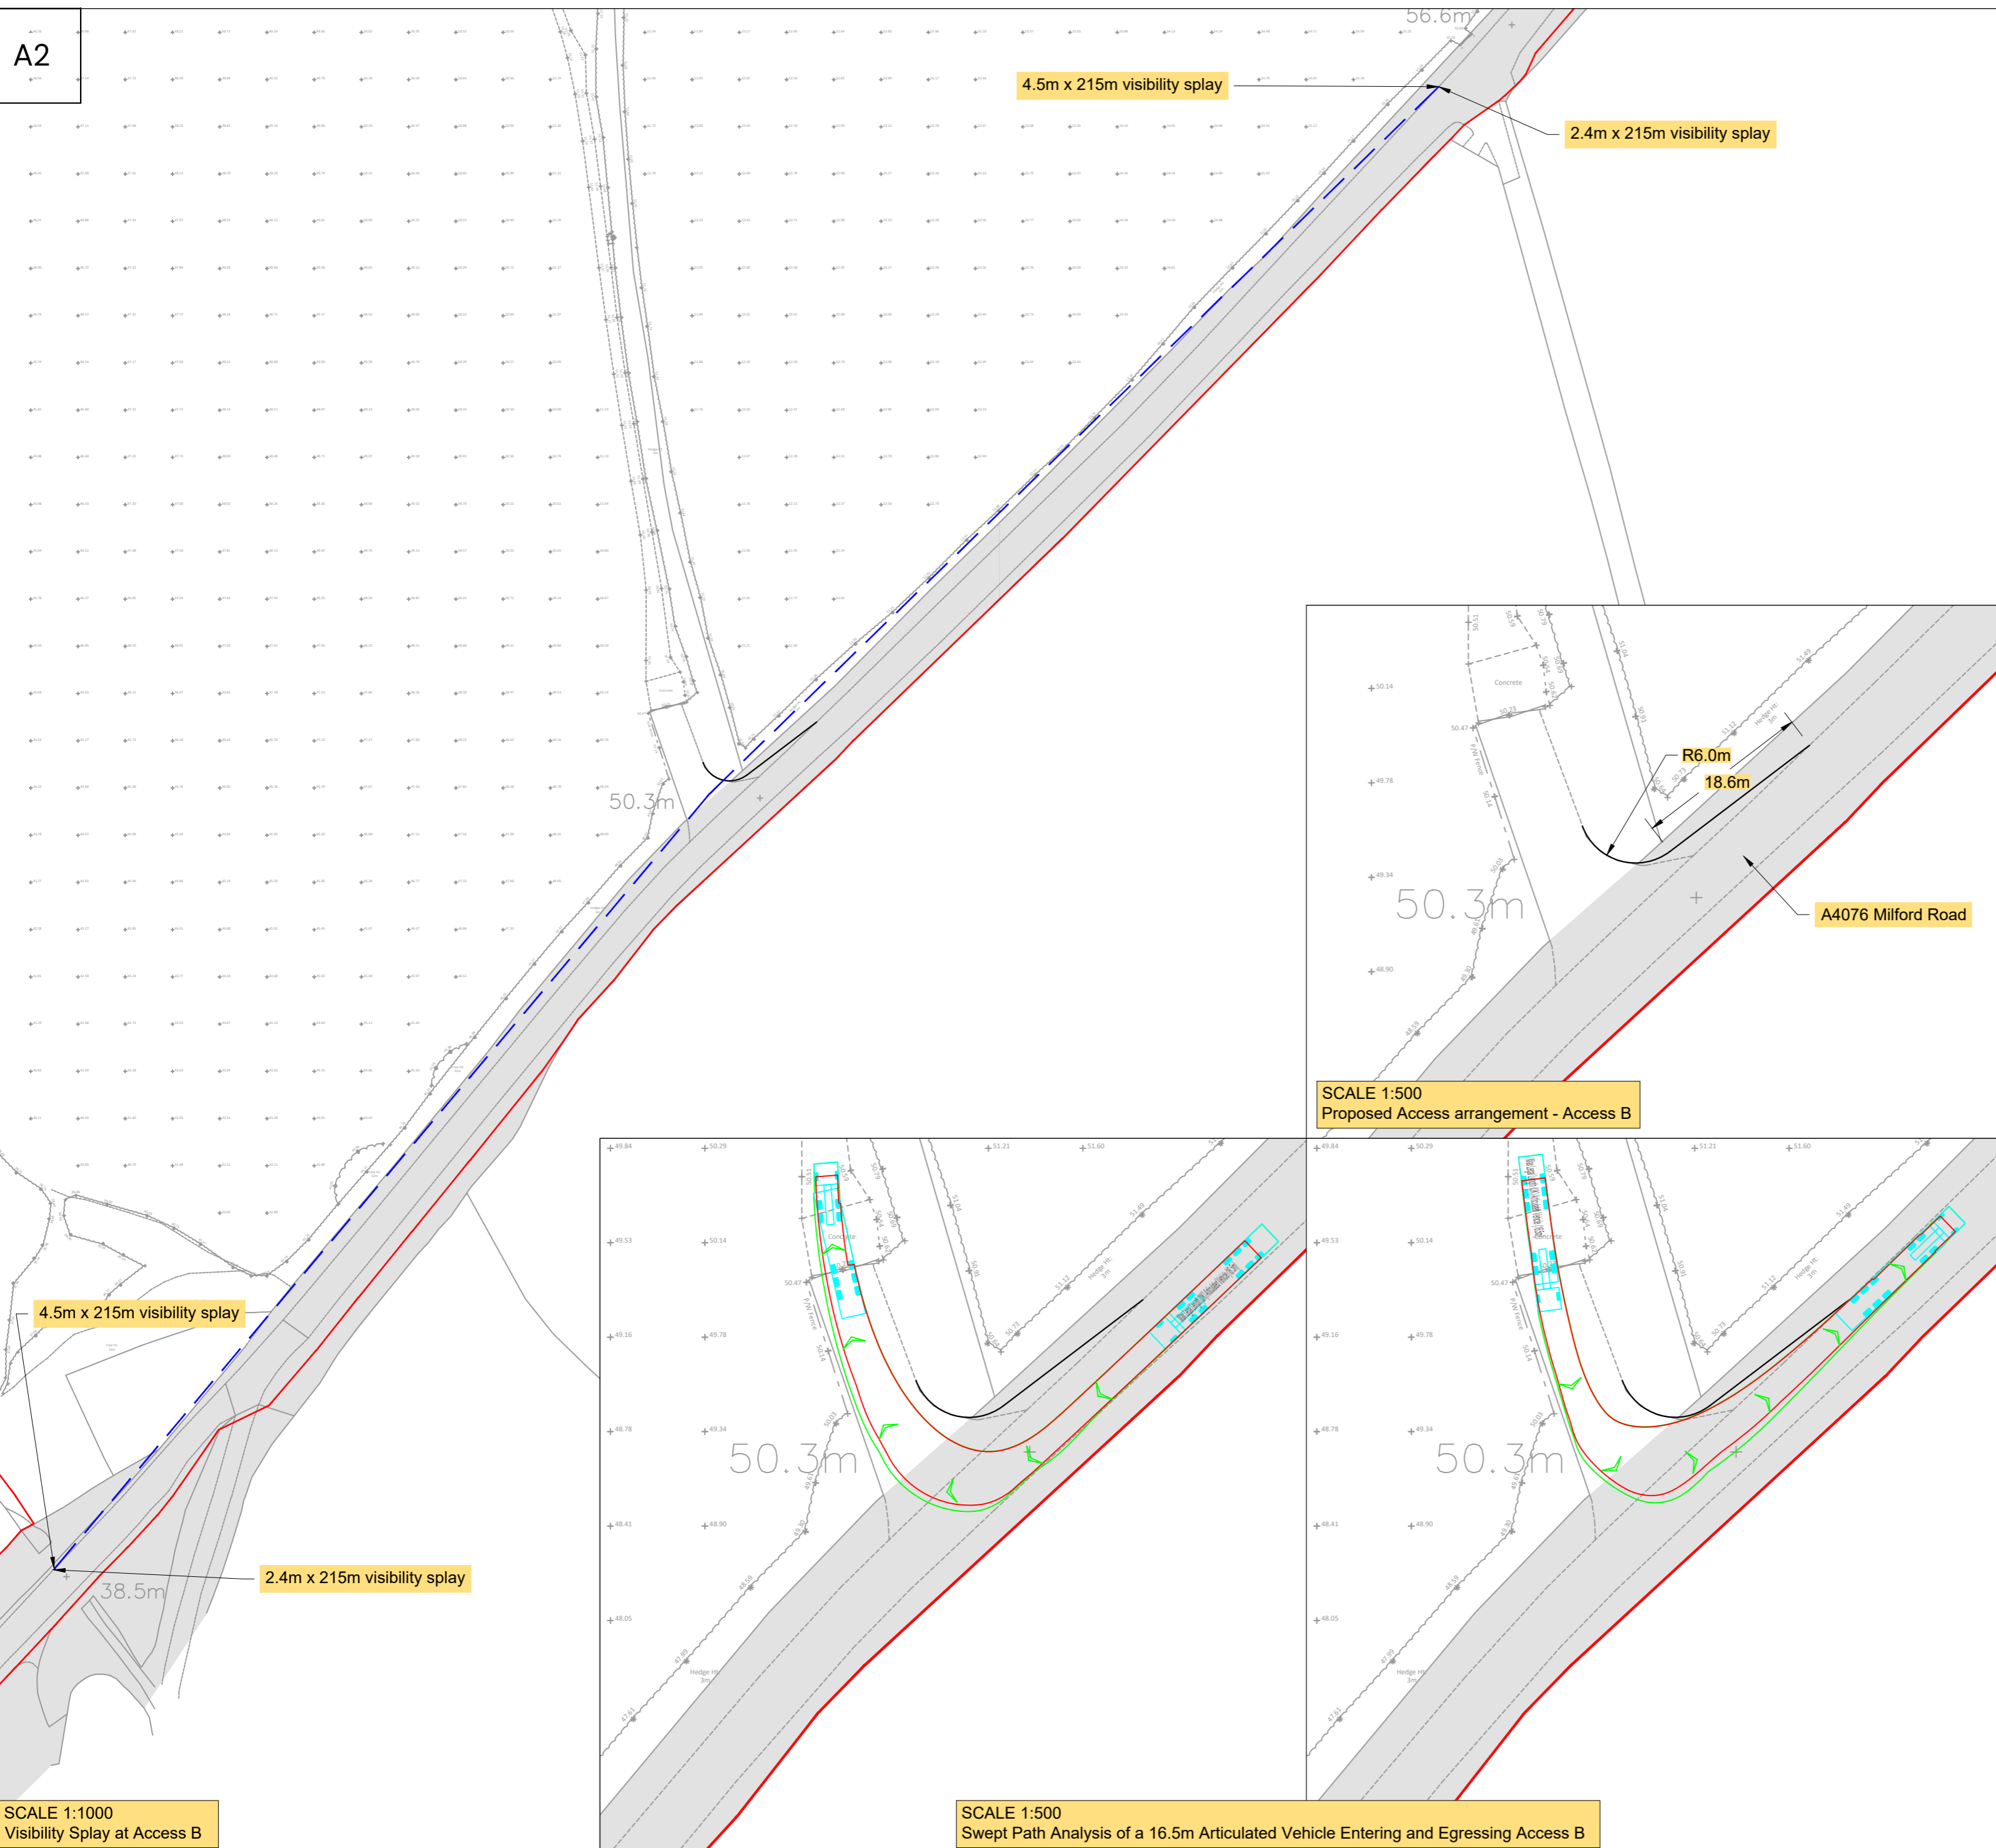
JOB No: P24-1037 DRAWING No: FIGURE 3.3 REVISION No: - **PEGASUS GROUP**

Max Legal Length (UK) Articulated Vehicle (16.5m) 16.500m  
 Overall Length 16.500m  
 Overall Width 2.550m  
 Overall Body Height 3.681m  
 Min Body Ground Clearance 0.411m  
 Max Track Width 2.500m  
 Lock to lock time 6.00s  
 Kerb to Kerb Turning Radius 6.530m

SCALE 1:500  
 Proposed Access arrangement - Access B

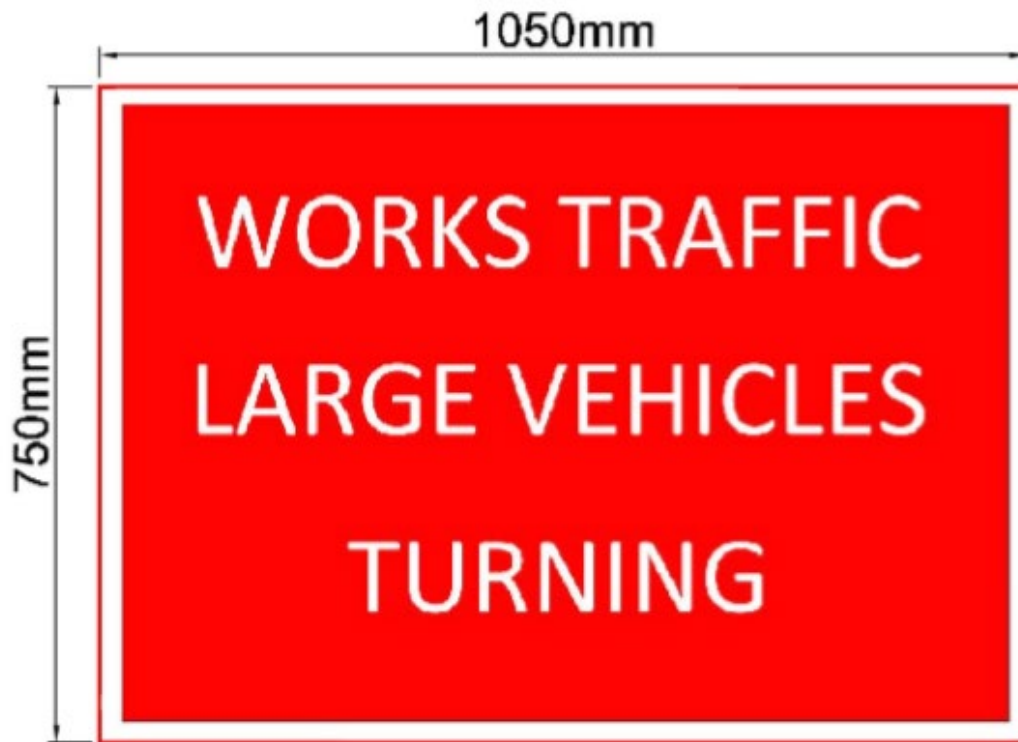
1. Temporary Construction Traffic signage (Diagram 7301 'WORKS TRAFFIC' in the TSRGD)
